Asian Journal of Geological Research

1(2): 101-109, 2018; Article no.AJOGER.44237

Geotechnical Properties of Subgrade Soil along Failed Portions of Akungba-Ikare Road Stabilised with Rock Fines

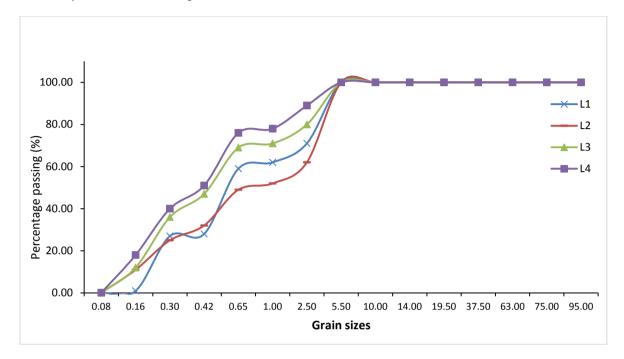
Fig. 3. Graph showing grain size analysis

The results obtained for grain size analysis are shown in Fig. 3. The % finer passing 425µm sieve range between 33 and 51. These values show that the samples are not suitable as subgrade materials because their values are higher than the standard specifications [23].
