## **Assessment of Drinking Water Catchments in Fako Division, South West Region, Cameroon**

**Case Study**

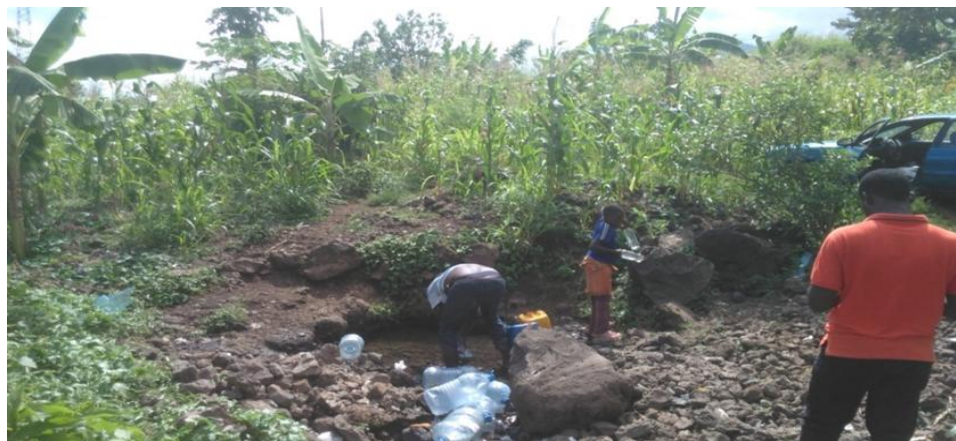
We also found out that, 20% (3 out of 15) are open springs of which in two of the catchments, consumers enter with feet to fetch drinking water. (Fig. 1, Table 1).

**Fig. 1. Farming less than 30 m from catchment at mile 2, not concreted, not fenced and consumers dipped feet and containers in spring to fetch drinking water**  
(Source: Authors)

5	Mile 2	Open Enter with feet in water meant for drinking				Roof on catchment Health education to stop entering with feet in drinking source to fetch water/pipping of water
6	Bolikawo(small soppo) camwatr	Surface water (stream) Farm <30 m Standing water				Stop farming <100m from catchment Drain standing water around.
7	Ndongo (Mutengene) CDC	No fence Open source				Fence catchment Roof on catchment
8	Ikande	No fence Standing water	Microbial	Medium risk	Water borne disease	Fence catchment Drain standing water around.
9	Kombe	Farm < 30 m				Stop farming <100m from catchment
10	Moli	Open source		High risk		Concrete catchment
11	Bwitingi	Interrupted fence Farm <30 m	Microbial Pesticide			Fence catchment Stop farming < 100m
12	Wotutu	House /Septic tank <100 m Open Interrupted fence Farm <30 m				Stop building houses <100m Appropriate regular treatment, monitoring and surveillance. Roof on catchment

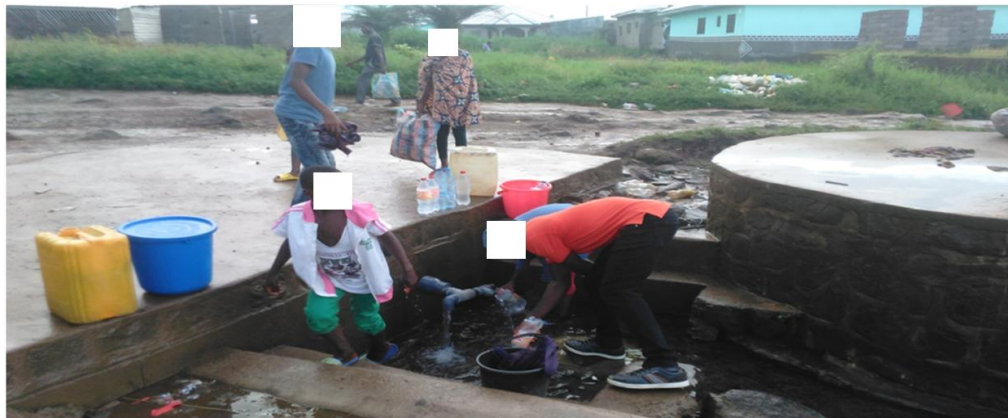
We observed that, 23.6% have houses with septic tanks <100 meters (Fig. 2).

**Fig. 2. Ameng water catchment mile 16 with motorable road, open refuse dump, standing water, houses with septic tank all around less than 100 meters**  
(Source: Authors)

13	Ameng	No fence Motorable road beside House/Septic tank<100 m Open refuse dump<100 m	Microbial			Deviate road away from catchment if possible but can be quite costly. However it can be cost effective to build high concrete fence around catchment. Stop open refuse dump around catchment. Appropriate regular treatment, monitoring and surveillance.
14	Solidarity (borehole),	House <100	Microbial	Moderate risk	Water borne disease,	Regular laboratory analysis of source water
15	Mile 18 (Borehole)	Farmland in the past	Chemicals from fertilizers		Cancer

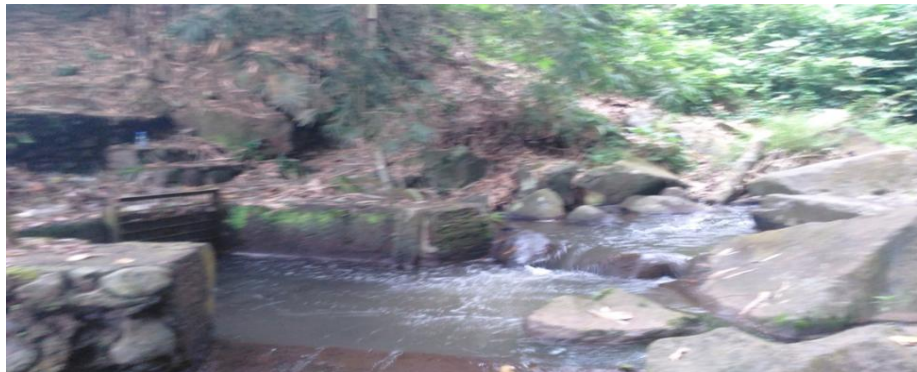
The results showed that, 13.3% of the water sources were surface water as seen in Fig. 3.

**Fig. 3. Showing Surface water source of Ndongo, Mutengene, farming around and not fenced**  
(Source: Authors)
